Coos Bay Lowland Assessment and Restoration Plan

Chapter 3: Echo Sub-basin Restoration Opportunities

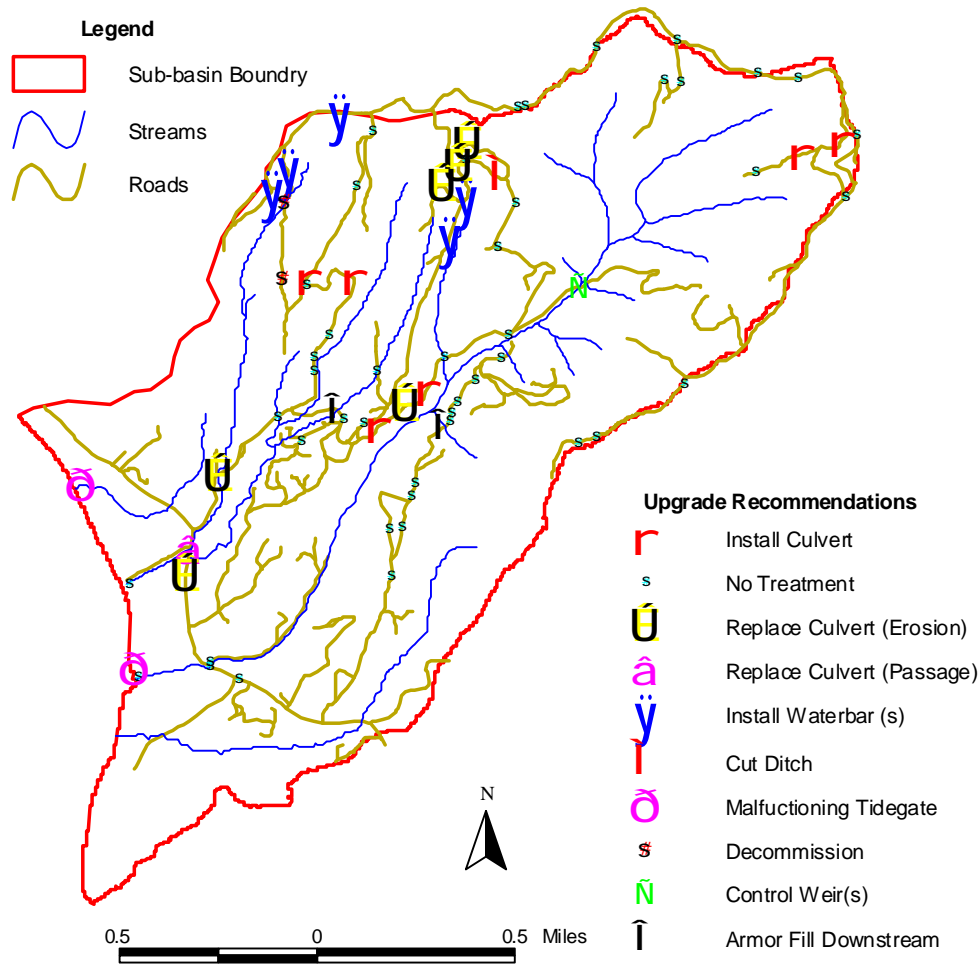
Figure E-20
Road & Landing
Treatment Recommendation
Locations

Road and landing treatment recommendations (see Table E-10) are site-specific fixes that bring road drainage problems up to date with current, 2003, Oregon Department of Forestry Best Management Practices (BMP). Based on the Coos WA road and landing surveys, the Echo sub-basin needs 42 new ditch relief culverts to reduce road related sediment. Of the existing structures, 4 stream crossing culverts need to be replaced, 3 are rusted out

and eroding the road fill under the pipe and the 1 culvert that is listed as fish passage barrier is undersized and 20% restricted due to the crushed outlet. Three ditch relief pipes are rusted out and need replacing and 13 water bars should be cut to upgrade ditch out and gullied road surface sites. Treatment site locations are shown in Figure E-20, below.

There were two stream crossing culverts that are especially undersized; they are both 48 inch culverts that drain over 1.1 square miles each. At least 100 cfs of water is backed up behind these culverts during high flow events, and each require at least 72 inch culverts to pass a 50-year event. Most of the fill at risk in this sub-basin is in the very high and high categories.

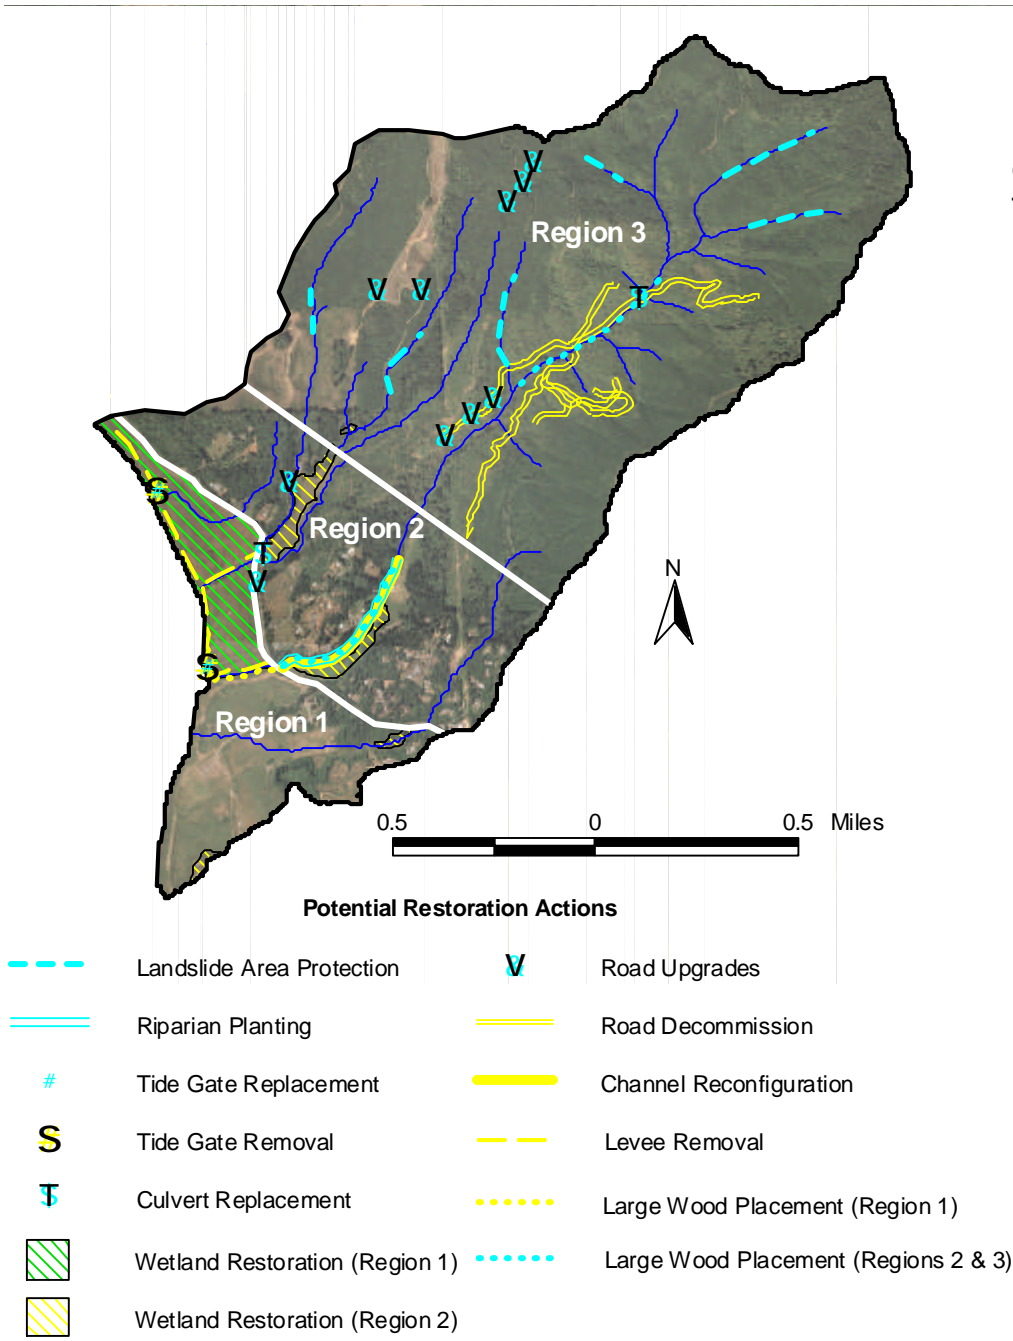
Figure E-21
Potential
Restoration
Opportunities

Results of the prioritization process for the Echo sub-basin are mapped below in Figure E-21. Legend colors indicate how the action scored within its region and implies the general approach that CoosWA would take to the action type. A description of the prioritization process, scoring and action types is provided in Chapter 3 – Restoration Strategy.

Potential actions within Region 1 are listed in Table E-11 and shown in Figure E-21. As the table indicates, the only green priority level action in the Echo sub-basin is wetland restoration in Region 1. This action scored higher in this region than in Region 2 since projects affecting East Bay Drive (the need to move fill and close the road while working) and pose a significant increase in cost and implementation feasibility. Estuarine wetland restoration in Region 1 scored high for both biological returns and socio-economics. Potential actions receiving a yellow priority ranking in Region 1 include tide gate removal, tide gate relocation, levee removal and large wood placement. The yellow priority level of these actions indicates high estimated biological returns, yet lower socio-economic favorability. The blue priority level potential action of tide gate replacements received lower scores for biological returns and higher scores for socio-economics. CoosWA would provide recommendations for tide gate replacements but not take a lead on seeking funds. Potential actions in Region 1 receiving the red priority level both scored low in the biological and socio-economic criteria and are not included on the restoration opportunities map.

Potential actions within Region 2 are listed in Table E-11 and shown in Figure E-21. Yellow priority level actions in Region 2 include reshaping the stream channel (channel reconfiguration), beaver encouragement and wetlands restoration. Blue priority level actions include large wood placement, willow wall construction, and implementation of farm plans. Neither beaver encouragement nor implementation of farm plans are shown on the map due to the impracticality of display. The red priority level actions all received low scores for both biological and socio-economic criteria and are highly unlikely to be implemented

shown in Figure E-21. Road decommissioning received the highest level ranking in this region, although it scored below a two for socio-economics it scored higher for biological returns. Blue priority level actions include riparian forestry practices, large wood placement, culvert replacements for fish passage, road upgrades, and landslide area protection. These actions scored higher in the socio-economic criteria and lower for biological returns. CoosWA would not take a leading role in developing funding for these projects. There were no red priority level actions in this region.
