**Coos Bay Tidal Wetlands Assessment:
Isthmus Slough, Coalbank Slough, Catching Slough and Echo Creek Sub-basins**

**May 5, 2010 Draft
OWEB Grant 208-2007
Coos Watershed Association**

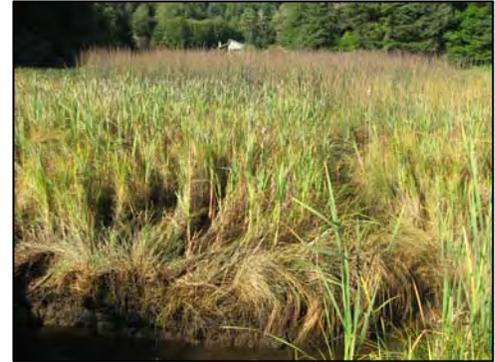
This site was reconnected to Catching Slough in 2003 by removing the broken tide gate and replacing the perched stream-crossing culvert under Old Wagon Road. Old cedar culverts draining either side of the site were filled and channels routed to the main culvert. The dike on which the county road is built separates the wetland edge from the mainstem Catching Slough, while the new culvert serves as the main conduit for tidal inundation. The project was intended to open access to 0.75 miles of salmon habitat in two tributaries above the wetland.

Perrin wetland from Old Wagon Road dike, August 2008.

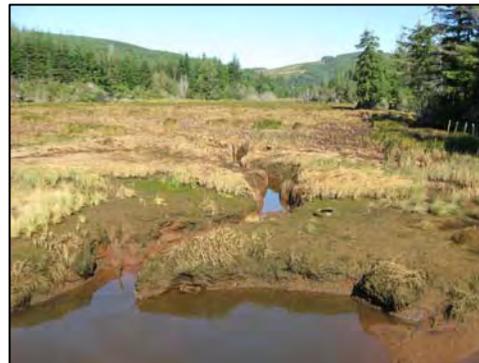
Scour pool and blind channel in front of main exit culvert, Davis DSL II site, 2008

The main fresh water channel exits through a culvert under the gravel road/dike. Within the last few years the culvert was replaced with a larger one, and therefore tidal inundation has increased - changing the vegetation community and channel structure. The 2005 aerial photos show a more pasture-like appearance than there was at the time of assessment. A natural blind channel is forming directly adjacent to the culvert's inside scour pool (shown in photo), but the channel running along the south side of the site was used for assessment measurements.

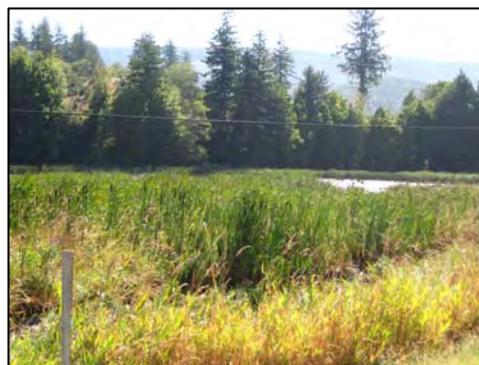
Seelander wetland, August 2008.

This site was tidally reconnected in 2003. At that time a small, flow-constricting culvert was replaced with a large pipe arch directly joining Catching Slough. That project increased tidal inundation while decreasing the flow velocities associated with the undersized culvert.

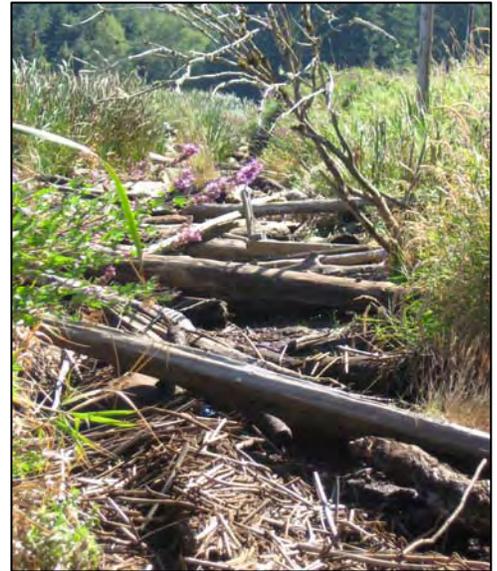
The history of land use at the site is quite interesting. The site has been inundated as a freshwater marsh for at least ten years. The area inundated was originally within the channel of Catching Slough, as indicated by the State of Oregon owning a meandered portion through the existing pond. A railroad track on trestles bisected the original channel, and according to locals, a pond was created to store logs. A noteworthy characteristic of this wetland is the high amount of large wood debris observed in one of the ditched channels along the western perimeter of the site (see photo). The wood may be relicts of the site’s history as a log storage pond.

Large wood at Seelander wetland, August 2008 (note loosestrife in foreground).

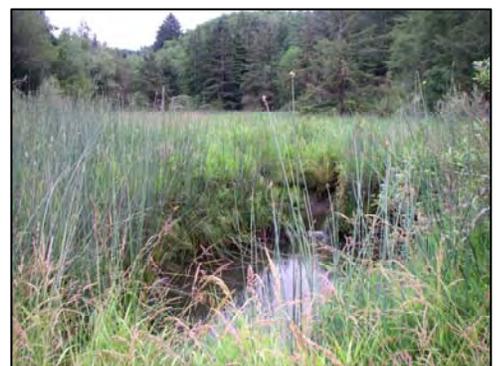
Little Matson wetland culvert’s tidal scour pool, August 2008.

The site appears to have strong fresh water influence, evident by the amount of freshwater wetland plants. Twelve species were recorded in the transects, yet several species observed in the plots were not on the input form and therefore were not included in analysis. *Carex lyngbyei* (lyngby sedge 23%) and *Agrostis stolonifera* (creeping bentgrass 22%) combined composed almost half of the vegetation plot area. Tidal inundation may be improved through culvert replacement.

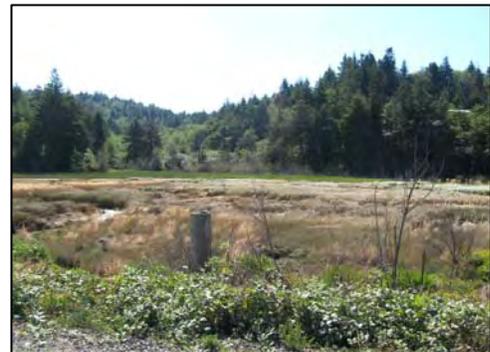
Paxton wetland from Red Dike Road, August 2008.

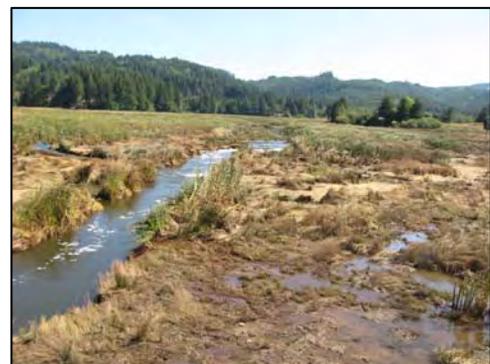
Matson wetland from Catching Slough road, August 2008.

At the time of assessment the site was in heavy transition. The near-mouth channels were actively eroding due to the sudden reintroduction of tidal action. In the middle of the site, the valley width was covered with water at low tide making foot access to the center of the site very unsafe. Additionally, the channels were not clearly defined and therefore the upper channel measurements were estimated.

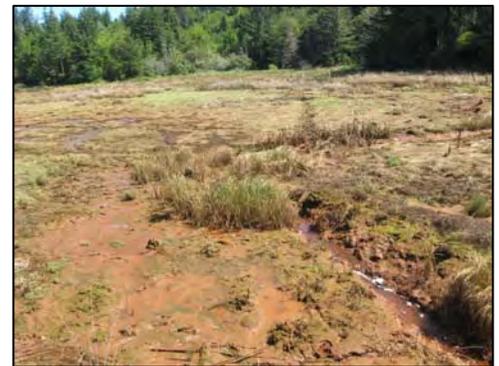
Brunschmid wetland near new outlet channel, August 2008.

Tidal inundation was restored to this site just previous to the assessment (summer 2008). Culverts and ditches along the sides of the valley were filled, and a new meandering channel was constructed through the mid valley. Intensive planting and seeding was conducted during 2008/2009.

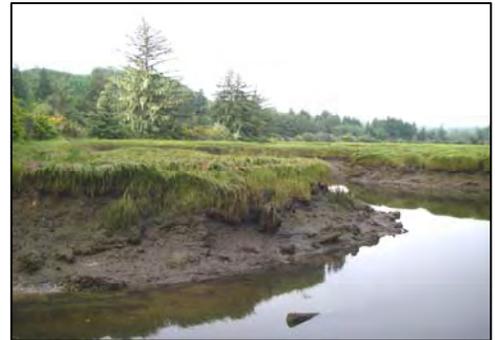
Upon site investigation, there did not appear to be hydrological connection between this site and the Davis DSL II site immediately ‘upstream’ to the west, and the only outlet for this site is at the channel mouth that was measured for the survey.

Davis DSL I Wetland near dike-breach where main channel enters site, Davis Slough Sub-basin, August 2008.

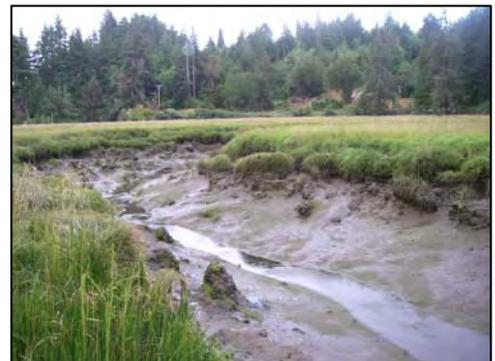
Main channel at Shinglehouse Mouth wetland, Isthmus Slough Sub-basin, August, 2008.

The site was used for mitigation of wetland disturbance resulting from nearby Highway 101 bridge work conducted in 1988 – 1989. At the time of assessment, specific goals and actions of the mitigation project were not identified in the DSL mitigation records. However, there appears to be a low berm within the site parallel to the Shinglehouse channel but not obviously a dike.

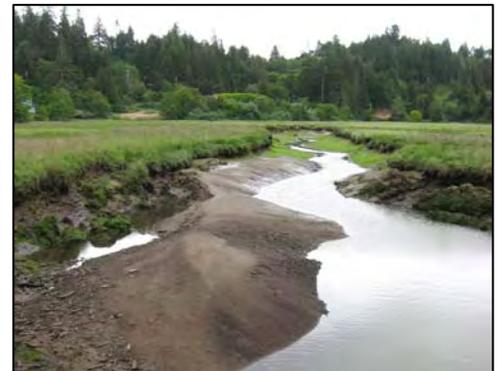
The large scour pool with active erosion and sediment deposition (see photo) indicated that the exit culvert was heavily restricting flow. Enlarging this exit channel would improve the estuarine salt marsh habitat and improve fish access to the habitat.

KCBY Wetland. Sediment deposition and main culvert scour pool, August, 2008.

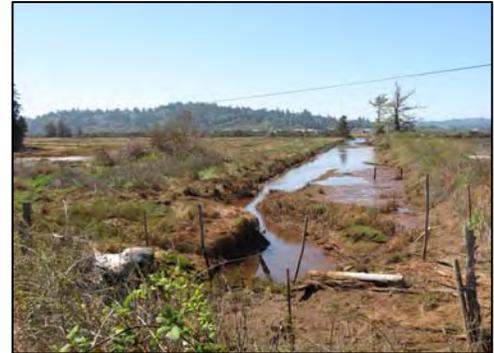
The site had ponded, impounded water in pannes, and in old ditches (i.e. east edge of site). The 2005 aerial images showed a contiguous dike on the Cooston Channel border, since then the dike was breached at the north end ditch. There also appeared to be some hydrologic connection with the neighboring marsh to the south evidenced by surface flow from this site to the ditch on the far side of the south end dike, and that ditch's connection to the neighboring marsh through an internal dike breach. Fresh water seepage at low tide was observed flowing under East Bay Drive from the Brunschmid marsh draining, not thru the box culvert, but seeping sub-surface near an old buried culvert.

Main channel into Demers Marsh, left. Demers Flat wetland is to the right. August, 2008.

This site and the Demers South (Flat) site are currently under consideration for restoration through dike removal.

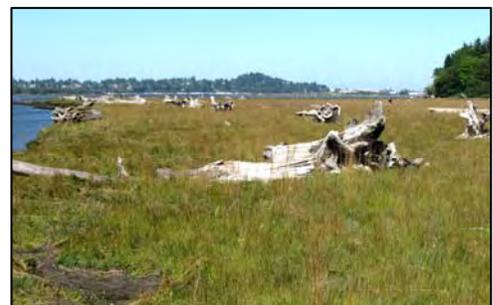
East Bay wetland with large wood, looking north along the Cooston Channel, August, 2008.

Residential development was encroaching along the northwest edge, road along the upland edge, and clear-cuts in upland drainage. The most notable features of the site were the un-diked edge with the estuary, and the large wood scattered on the surface and accumulating at the north and eastern edges. There were two major channels entering the site from the north (very wide channel) and south ends of the delimited site. These tidal channels joined in the middle at a very small juncture.

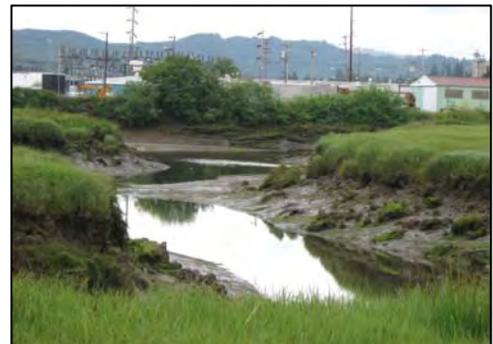
Characteristic tidal channeling was observed throughout the site, as well as pannes. Very little wood was observed on the marsh surface or in the channels, a likely result of the surrounding dike with only one breach. A gravel road on the upland side of the marsh is set back from the site edge by more than 100 feet along most of its length, and industrial and commercial land uses are directly across the Coalbank Slough channel.

Mouth of main channel into the Bickett wetland adjacent to a Coos Bay industrial area. May, 2008.

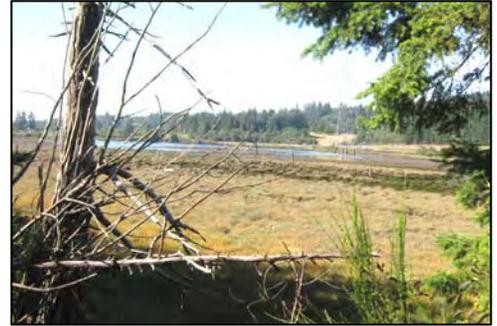
Hong wetland from county road, dike and Isthmus slough in background, September, 2008.

This site was diked and drained pre-1939. The dike is assumed to have been breached >10 years ago. The mucky soil was relatively more compact (observation only), possibly due to historic livestock use combined with bark accumulation from nearby log rafts. The outer dike seemed largely composed of large wood debris. Driftwood edge existed along the majority of the perimeter – although less wood volume than the East Bay site. There were pilings within the site along some of the channel areas, and there was a large electrical line structure on the site (south of assessment boundary), that could potentially influence future management actions.

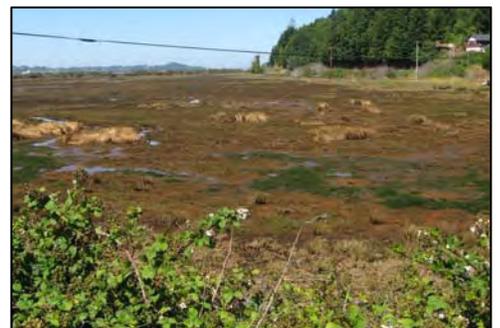
Demers Flat wetland near southeast corner, August, 2008.

The most notable features of the site were the extensive dikes, the pedestal soil formations, and the relative lack of large, leafy vegetation. Six plant species were recorded in the transects; dominated by *Eleocharis parvula* (dwarf spikerush 57%), *Carex lyngbyei* (lyngby sedge 16%), and *Salicornia virginica* (pickleweed 12%).
