Restoring Willanch Creek

Fifteen Years of Cooperation Benefiting Salmon

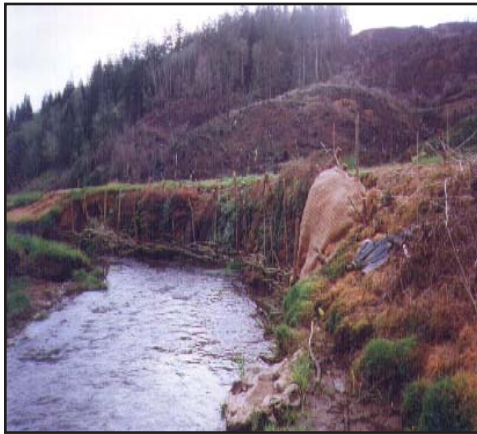
Willow wall construction helped to shade the stream and lower the water temperature. (Photo taken in 1997.)

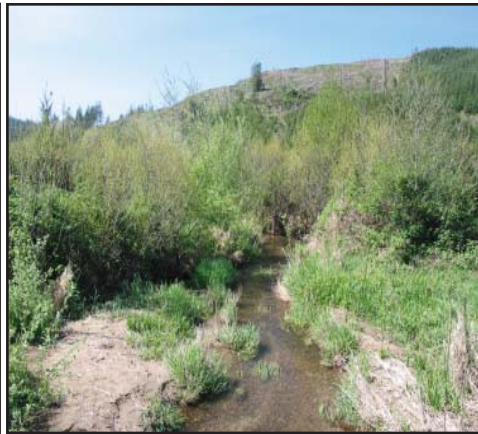
Riparian vegetation growing in Lower Valley assisted the greater than 10°F drop in stream temperature. (Photo taken in 2004.)

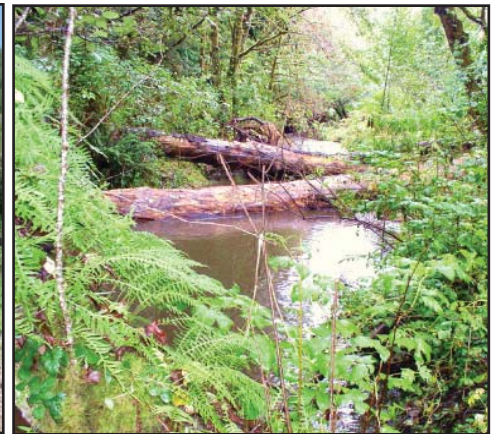
Large wood placed in Willanch Creek in 2004 aided in enhancing stream complexity.

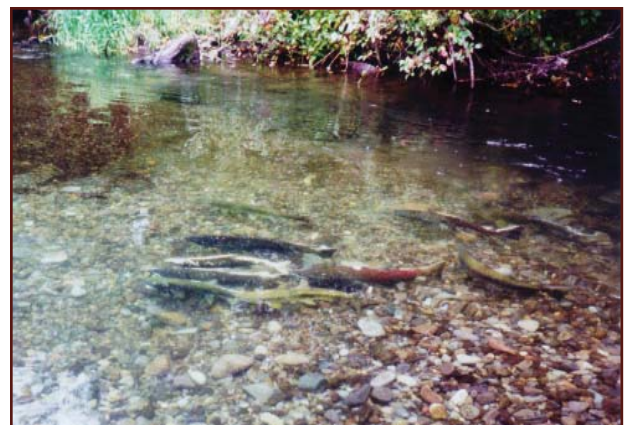
Salmon spawning in Willanch Creek where the gravel streambed is ideal for spawning. (Photo taken in 2009.)

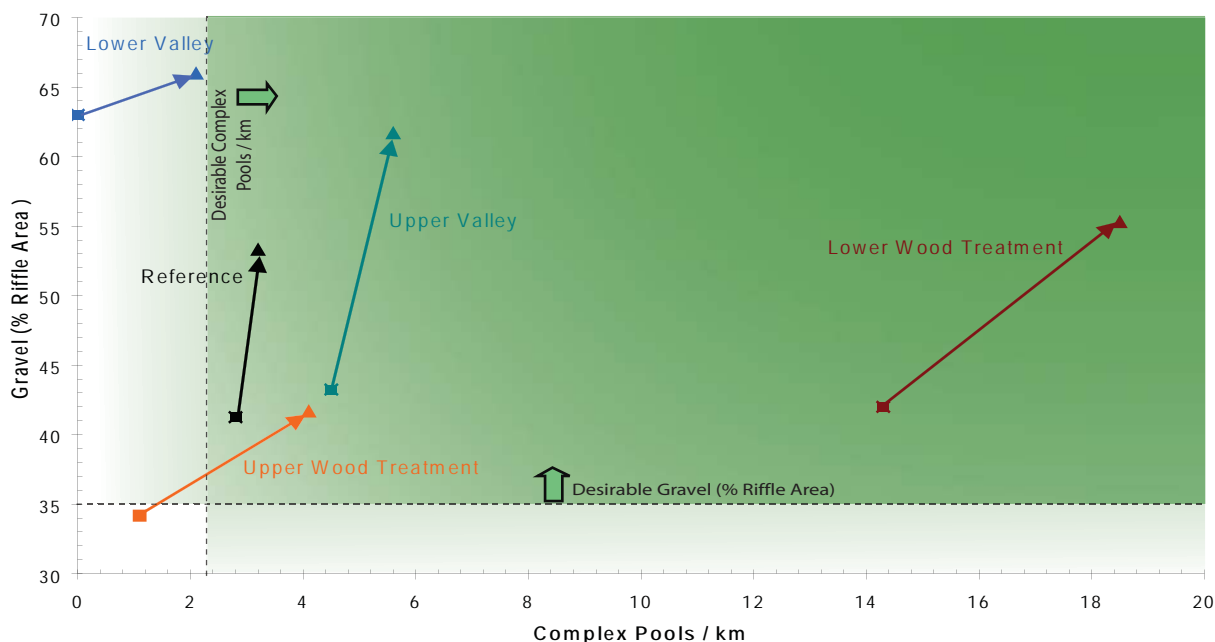
Change In Two Important Habitat Parameters From 2001 to 2009

Figure 2: All reaches showed improvement in the percent of gravel and the complexity of pools. In 2009 all reaches except the Lower Valley met these benchmarks.

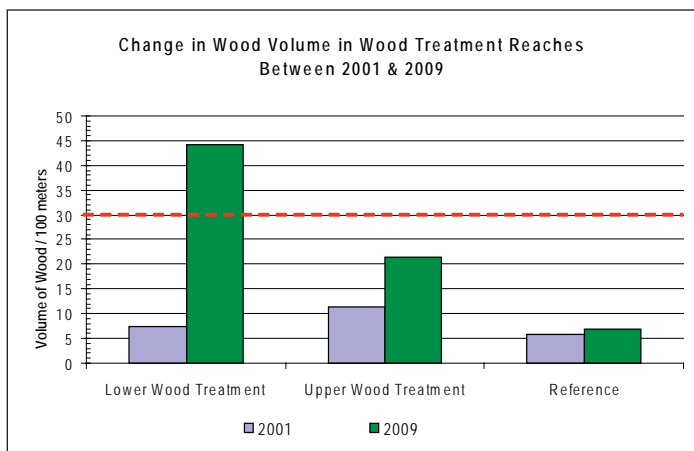
Figure 3: Increase in wood volume in the reaches where large wood was added to the stream. The Lower Wood Treatment Reach met the ODFW benchmark in 2009. (Lower Valley and Upper Valley Reaches not shown since they were not treated with wood.)

removed large woody debris.) The Upper and Lower Wood Treatment sites were treated with large wood in 2005. The 2009 AHI showed that the Lower Wood Treatment site attained a desirable level of large wood (according to the ODFW benchmarks), but the Upper Wood Treatment site still lacked key pieces (Figure 3, page 5).

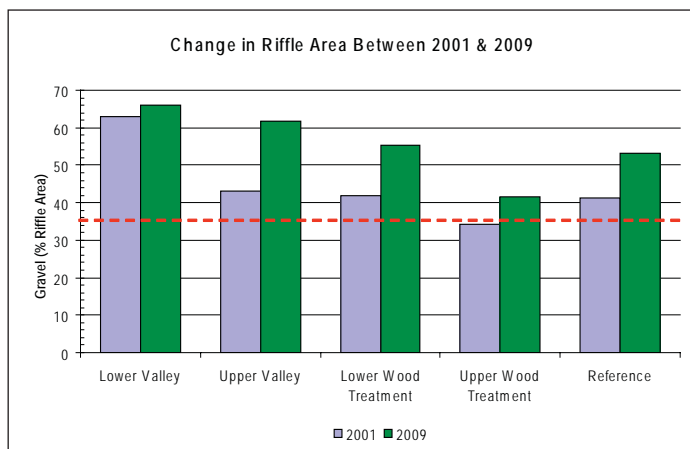
Figure 7: All reaches met the ODFW benchmark in 2009 for gravel (% riffle area).

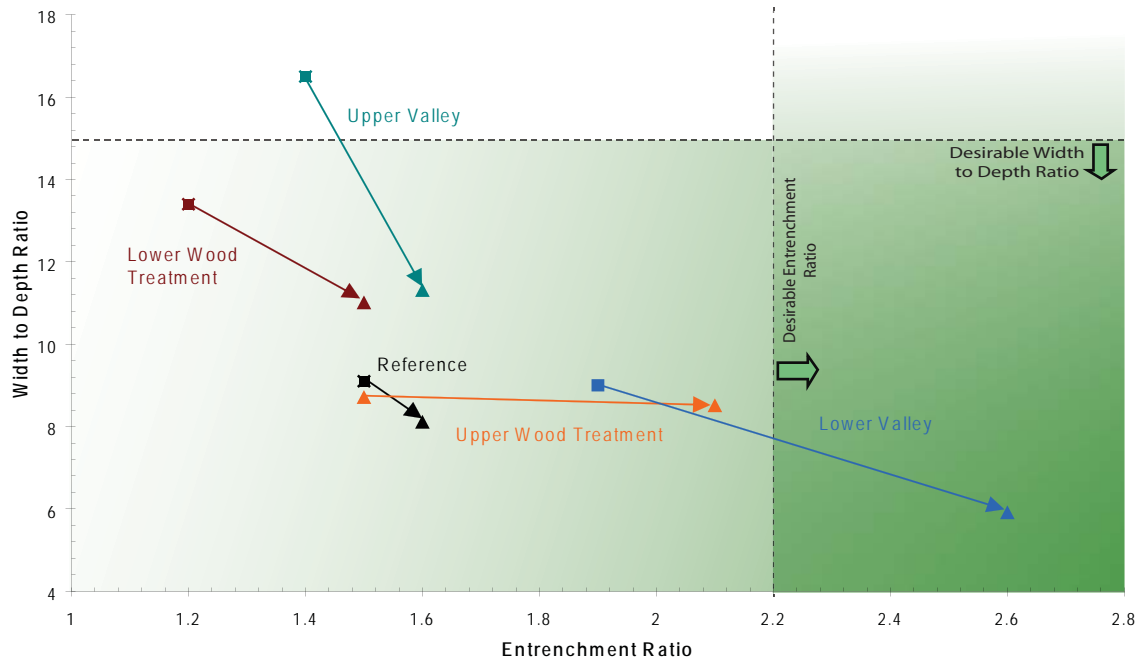
Change In Floodplain Connectivity From 2001 to 2009

Figure 9: Comparison between width to depth ratio and entrenchment ratio in Willanch Creek from 2001 to 2009. A decrease in width to depth ratio and an increase in entrenchment ratio is the desirable trend. The Lower Valley reach met both these benchmarks.

Width to depth ratio, shown in Figure 8, indicates the shape of the channel. Some streams are wide and shallow (high ratio), while others are deep and narrow (low ratio). The width to depth ratio was reduced in Willanch Creek through riparian planting and large wood placement. A desirable width to depth ratio, according to ODFW standards, is less than 15 for streams on the western side of the Cascades. Although four of the five reaches in the study had a desirable width to depth ratio in 2001, the 2009 AHI survey showed that all five reaches met this benchmark and four out of five improved (Figure 9).

warmer months. According to Rosgen (1996), an entrenchment ratio greater than 2.2 indicates a well-developed floodplain. The 2009 AHI survey showed that only one reach had a desirable entrenchment ratio; however, the remaining four showed improvement (Figure 9). Over time, gravels deposited at the large wood placement sites will improve entrenchment ratios.

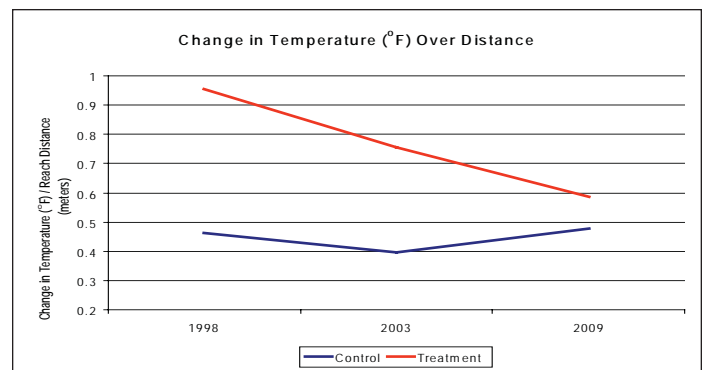
Figure 12: The treatment area where riparian planting took place showed a steady decrease in temperature from 1998 to 2009. This was attributed to shading and increased floodplain connectivity in that area. The control area from the upper to middle restoration area remained relatively stable during this time.

amount of shade from riparian vegetation. The relationship between shade and temperature is illustrated in Figures 10-12. Our main objective was to reduce stream temperatures to below 64°F. Over the twelve years of temperature data collection, the lower site showed a decrease in temperature from 74.2°F to 61.9°F—a 12.3°F reduction that satisfied the standard well; all sites met the DEQ temperature standard in the last four years of data collection. We hypothesize that the initial cooling was due to shading by riparian vegetation planted in 1997. The second period of cooling was likely due to improved channel entrenchment ratio that resulted in more floodplain connectivity. (A “well connected” floodplain allows flood water to soak into the banks; this cool water is later released to the stream.) Additionally, the planted trees apparently lured beavers into the area. Beaver ponds have naturally slowed the stream, further increasing floodplain connectivity and the stored water that is released into the stream during the summer.
